CERTIFICATE OF COMPLIANCE

Certified Product: Trademarks: Model(s): Technical Data: Rechargeable Li-ion Battery Storage System Deye GE-FH60, GE-FL60 GE-FH60: 614.4Vd.c, 100Ah, GE-FL60: 307.2Vd.c, 200Ah; Maximum charge current: 100A; Maximum discharge current: 100A,; Charge operating temperature: 0 to 55 °C; Discharge operating temperature: -20 to 55 °C

[Summary of Test results]

TRF_UL 9540A Unit_V1.0 Page 7 of 46

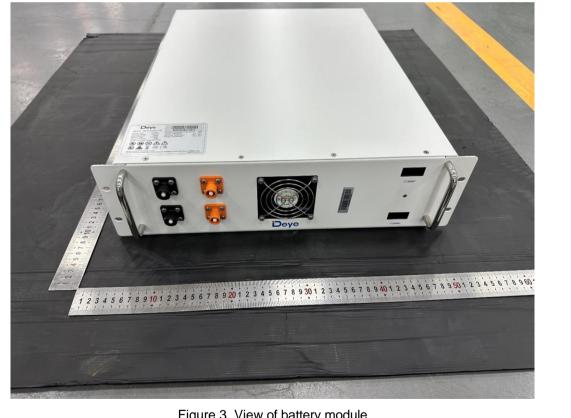
Figure 3. View of battery module

Model:	GE-F-Pack5.1-D	
Manufacturer:	NINGBO DEYE ESS TECHNOLOGY CO., LTD	
Nominal capacity:	100 Ah	
Nominal voltage:	51.2 Vd.c.	
Maximum charge current:	100 A	
Maximum discharge current:	100 A	
Maximum charge voltage:	57.6 V	
Cut-off Voltage:	43.2 V	
Charge temperature range:	0 °C to 55 °C	
Discharge temperature range:	-20 °C to 55 °C	
Module configuration:	16S	
External dimensions:	570 mm x 495 mm x 135 mm	
Enclosure material:	Metal	
Weight:	Approx. 45.0kg	
UL 1973 compliant:	Yes / No Reference: SGS contract No.: 801898

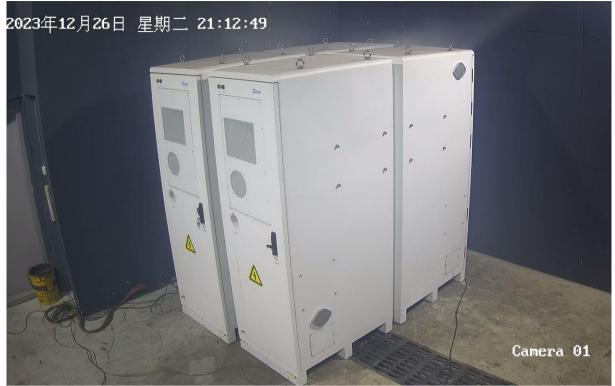
Figure 19. Photo of event (E3) during test

Time (HH: MM: SS)	Relative Time (HH: MM: SS)	Event ID	Event	Description	Photo Reference	
20:14:51	00:00:00	E1	Test Start			
20:18:37	00:03:46	E2	Heater 1 and heater 2 energized			
21:12:49	00:57:58	E3	Initiating Cell Venting	Smoke release observed.	Figure 19	
21:14:09	00:59:18	E4	Thermal Runaway Onset	Thermal runaway confirmed through temperature curve. Smoke release observed. Heaters de-energized.	Figure 20	
23:14:51	03:00:00	E5	Test Termination			
Test Start Time: 2023-12-26 20:14:51
