# CERTIFICATE OF COMPLIANCE

**Certified Product:** Rechargeable lithium-ion battery pack

**Model(s):** BOS-GX (X=15, 20, 25, 30, 35, 40, 45, 50, 55, 60),  
Battery module: BOS-GM5.1

**Certified Product:** High Voltage Hybrid ESS

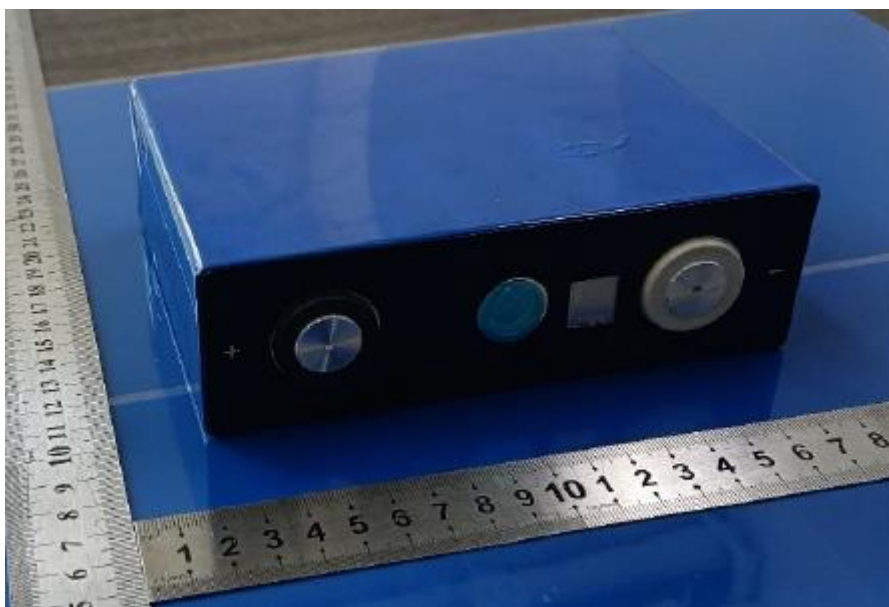
Figure 1. View of component cell

Model:	LF100LA	
Manufacturer:	EVE POWER CO., LTD	
Nominal capacity:	100 Ah	
Nominal voltage:	3.2 V	
Chemistry:	Lithium ion, LiFePO4	
Charge current:	100 A	
Discharge current:	250 A	
Maximum charge voltage:	3.9 V	
Cut-off Voltage:	1.9 V	
External dimensions:	49.9(±1.0mm) * 160.0mm(±1.0mm) * 118.5mm(±1.0mm)	
UL 1973 compliant:	<input checked="" type="checkbox"/> Yes / <input type="checkbox"/> No	Reference: UL (MH63503)
UL 9540A report provided:	<input checked="" type="checkbox"/> Yes / <input type="checkbox"/> No	Reference: UL report No.: 4790509108

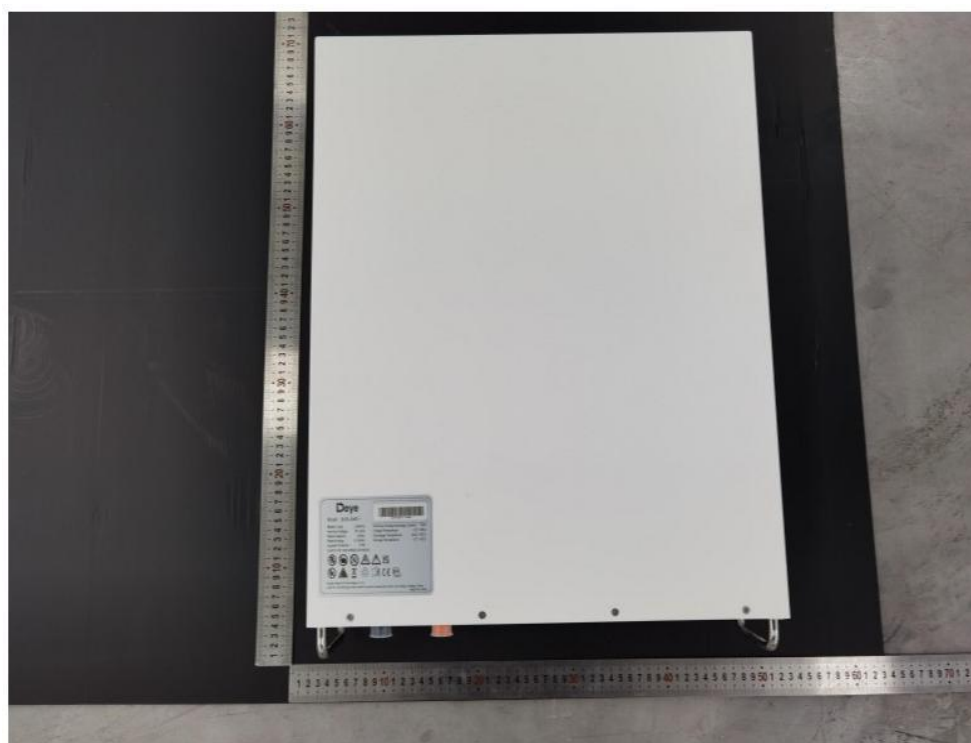
Figure 2a: View 01 of battery module.

Model:	BOS-GM5.1	
Manufacturer:	NINGBO DEYE ESS TECHNOLOGY CO., LTD	
Nominal capacity:	100 Ah	
Nominal voltage:	51.2 V	
Module designation:	1P16S	
Maximum charge current:	100 A	
Maximum discharge current:	100 A	
Maximum charge voltage:	57.6 V	
Cut-off Voltage:	45 V	
Charge temperature range:	0°C to 55°C	
Discharge temperature range:	-20°C to 55°C	
Module configuration:	16 Lithium ion cells in 16S cased by metal enclosure	
Enclosure material:	Painted metal	
Weight:	Appr. 44 kg	
UL 1973 compliant:	<input checked="" type="checkbox"/> Yes / <input type="checkbox"/> No	Reference: Contract No: 801898, issued by SGS
UL 9540A report provided:	<input checked="" type="checkbox"/> Yes / <input type="checkbox"/> No	Reference: SGS report No. CQES230200005301

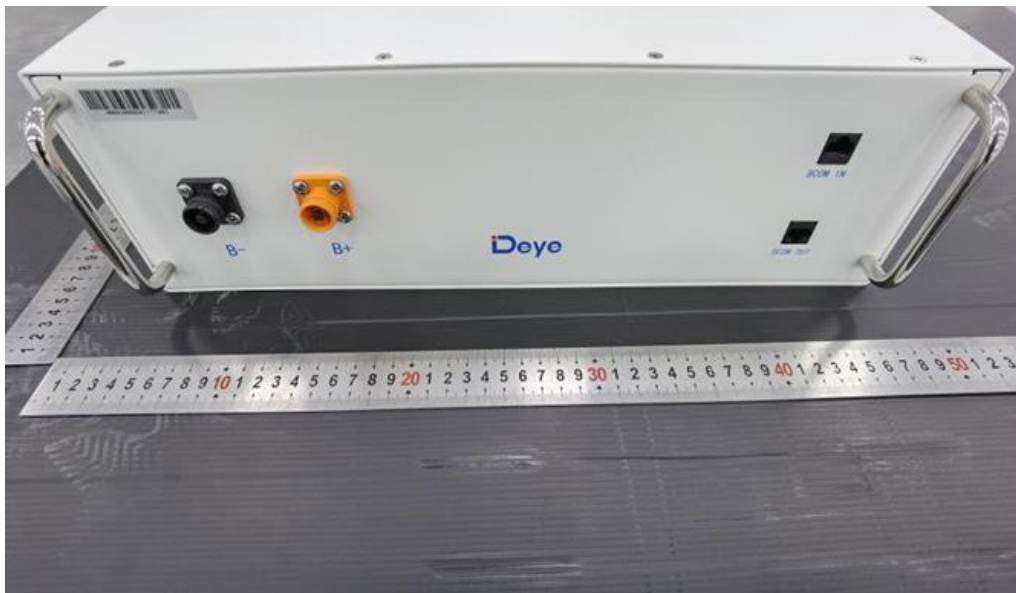
Figure 2b: View 02 of battery module.

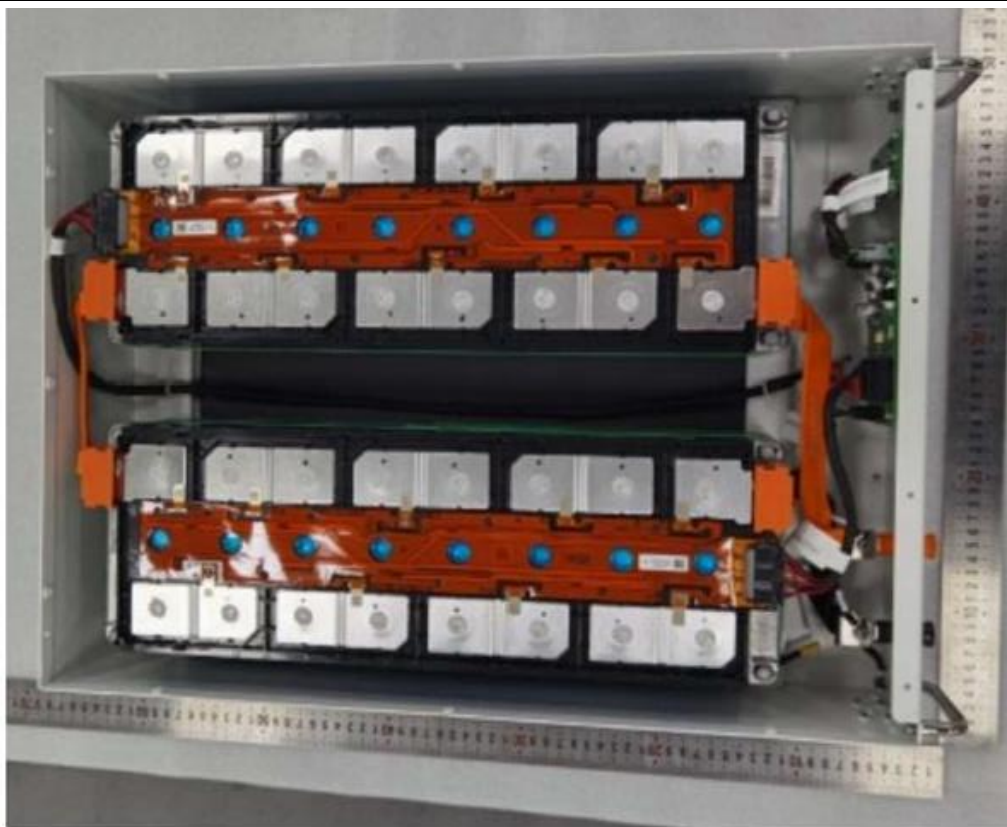
Figure 2d: View 04 of battery module.

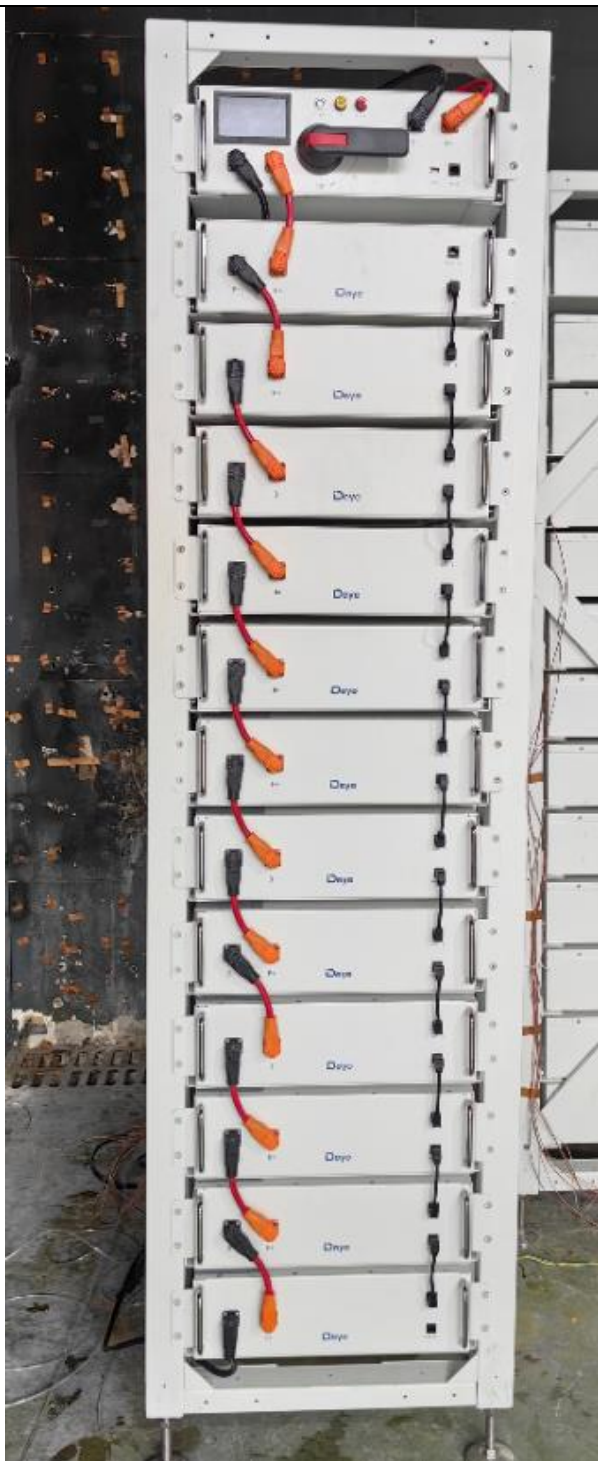
Figure 3a. External view 01 of battery system

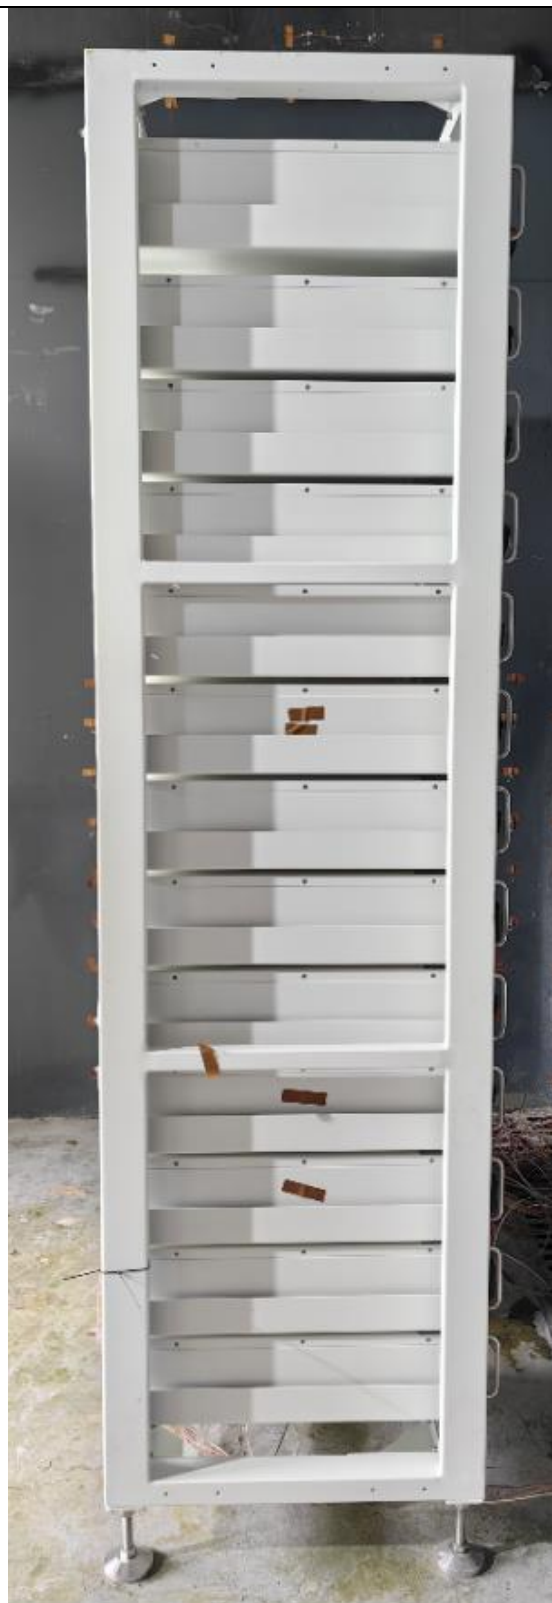
Figure 3b. External view 02 of battery system

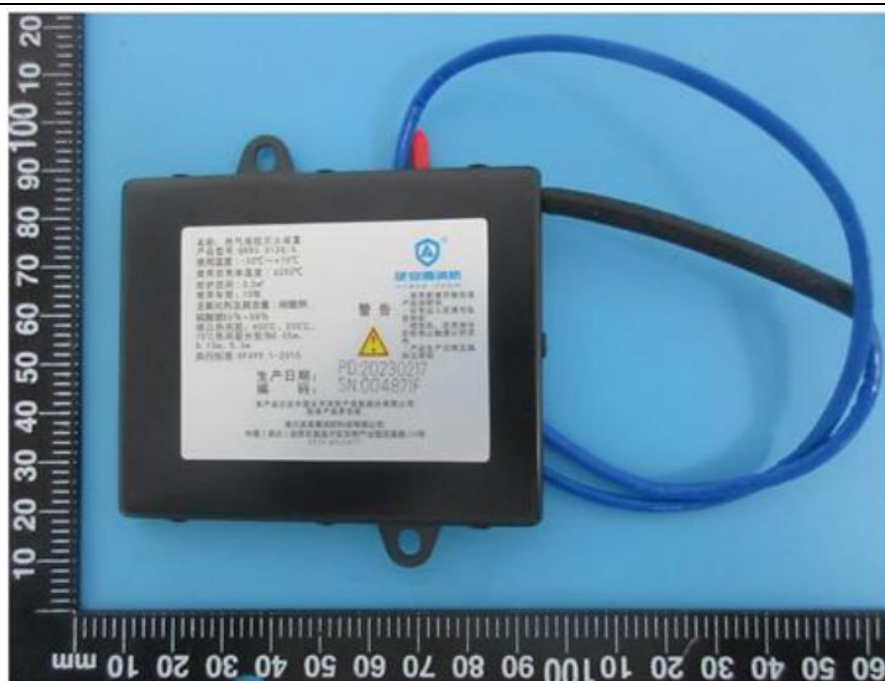
Figure 3f View of Aerosol unit (Internal side of battery pack)

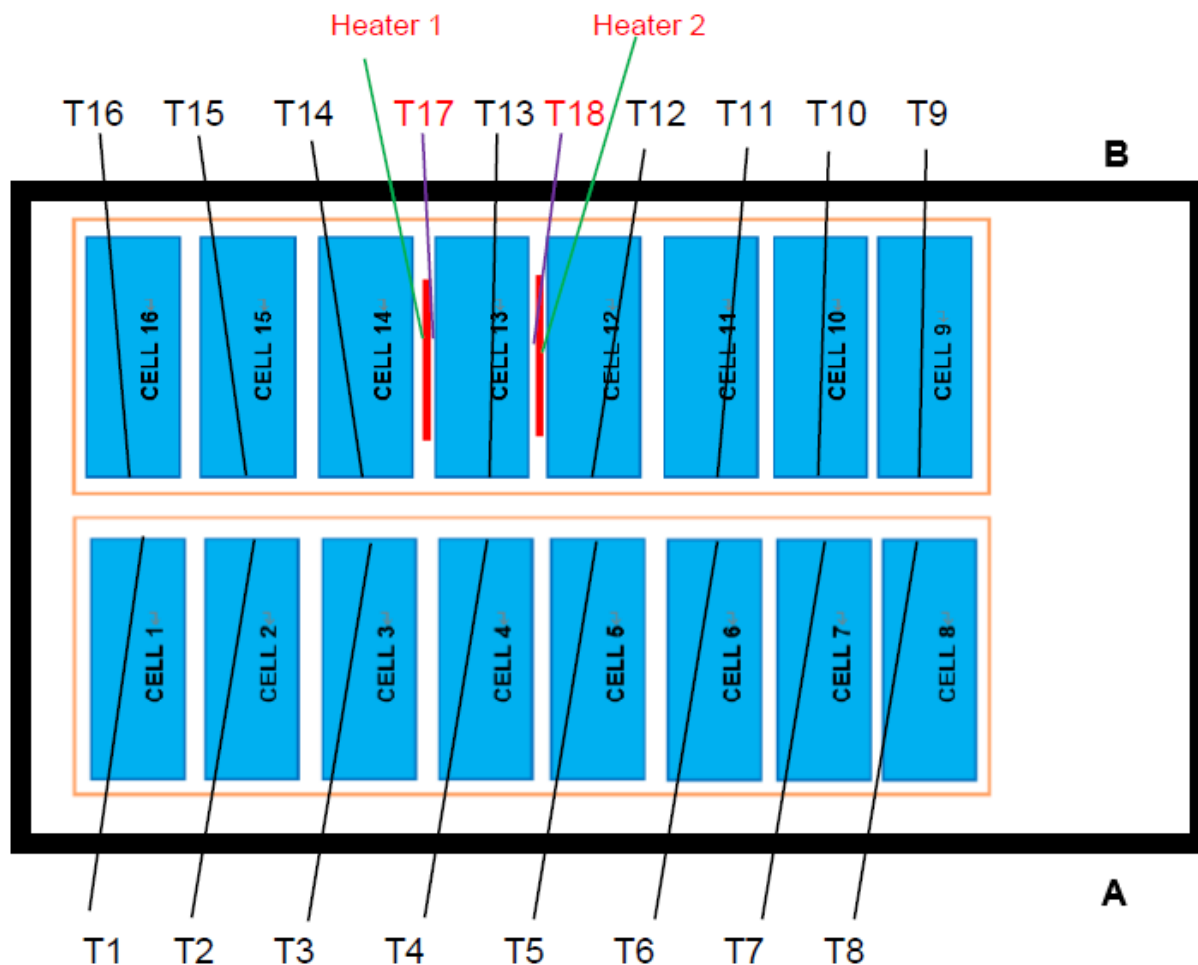
Figure 6. Schematic diagram of external heater and thermocouple locations in the initiating module (View from top).

No. 24-gauge or smaller, Type-K exposed junction thermocouples shall be installed to measure the temperature of the surface proximate to the cells and between the cells and exposed face of the initiating module. Each non-initiating module enclosure within the initiating BESS unit shall be instrumented with at least one No. 24-gauge or smaller Type-K thermocouple(s) to provide data to monitor the thermal conditions within non-initiating modules. Additional thermocouples shall be placed to account for convoluted enclosure interior geometries.

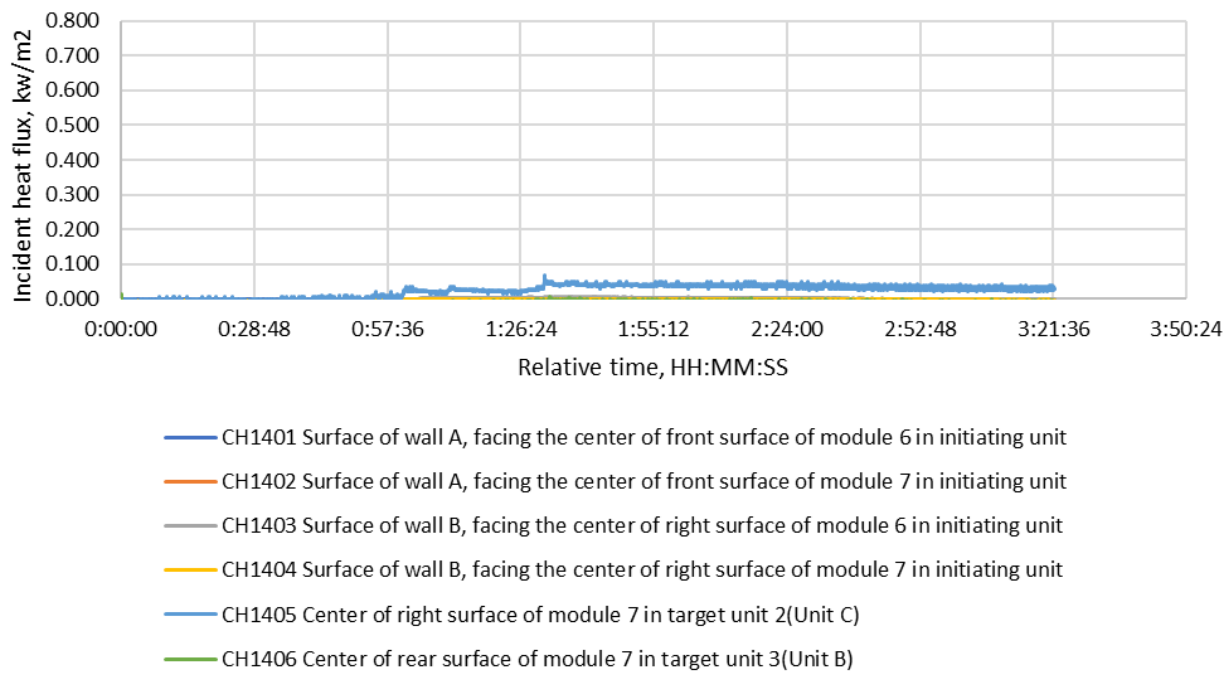
Heat Flux Sensor ID	Description of location
CH1401	Surface of wall A, facing the center of front surface of module 6 in initiating unit
CH1402	Surface of wall A, facing the center of front surface of module 7 in initiating unit
CH1403	Surface of wall B, facing the center of right surface of module 6 in initiating unit
CH1404	Surface of wall B, facing the center of right surface of module 7 in initiating unit
CH1405	Center of right surface of module 7 in target unit 2(Unit C)
CH1406	Center of rear surface of module 7 in target unit 3(Unit B)

Figure 9. Incident heat flux on target wall surfaces and target BESS units.

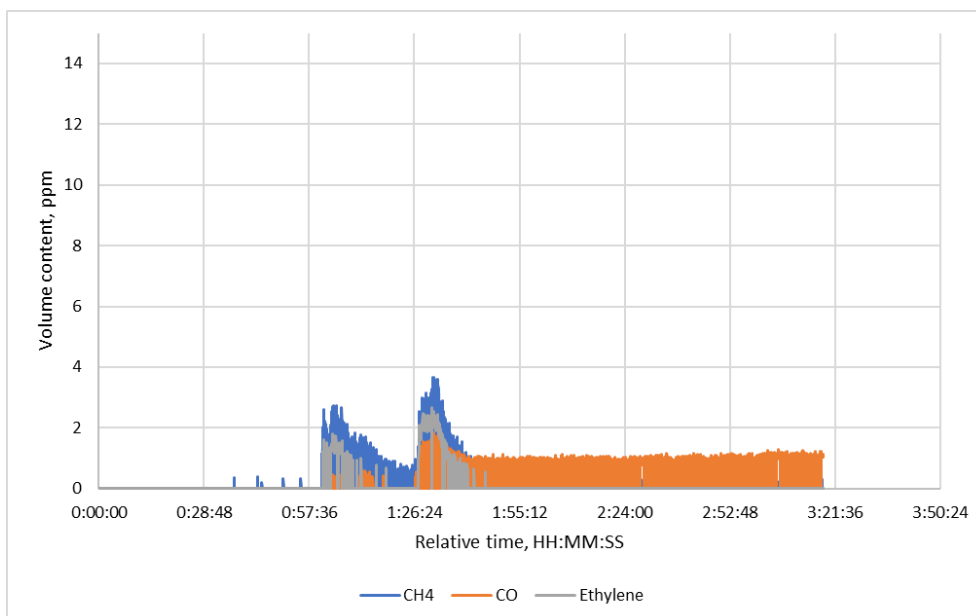
Figure 11b. Online flammable gas content measurements during test. (Remark: The content of other hydrocarbons is below the detection limit of the test equipment.)

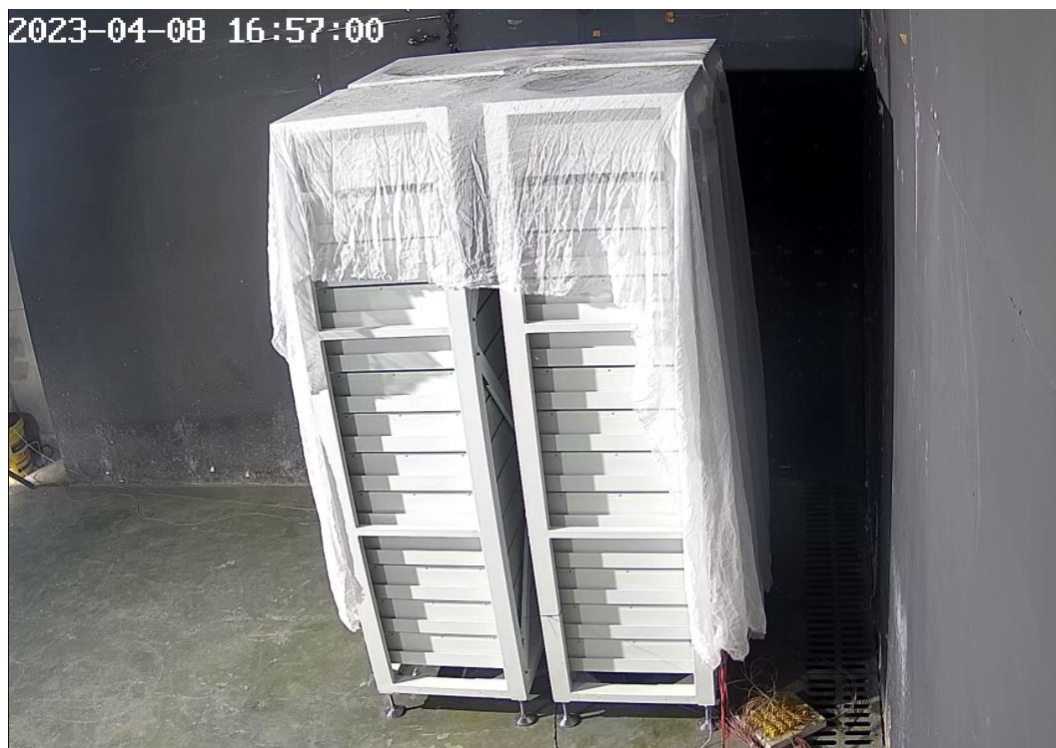
Figure 12. Photo of E1 (event 1) during test.

Time (HH: MM: SS)	Relative Time (HH: MM: SS)	Event ID	Event	Description	Photo Reference
16:57:00	0:00:00	E1	Test Start	--	Figure 12
16:58:00	0:01:00	E2	Heater 1 and Heater 2 Energized	--	--
17:57:45	1:00:45	E3	First Release	Smoke release observed from initiating battery system enclosure.	Figure 13
18:24:42	1:27:42	E4	Second Release	Smoke release observed from initiating battery system enclosure.	Figure 14
20:18:47	3:21:47	E5	Test Termination	--	--

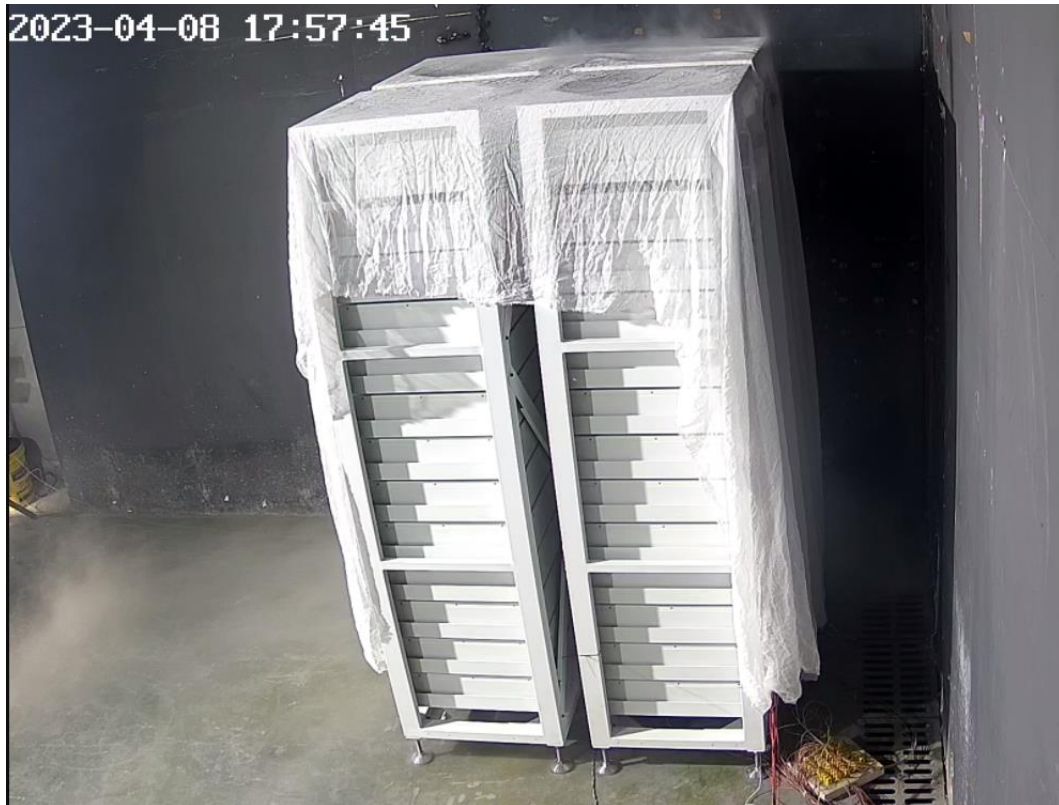
Figure 13. Photo of E3 during test.

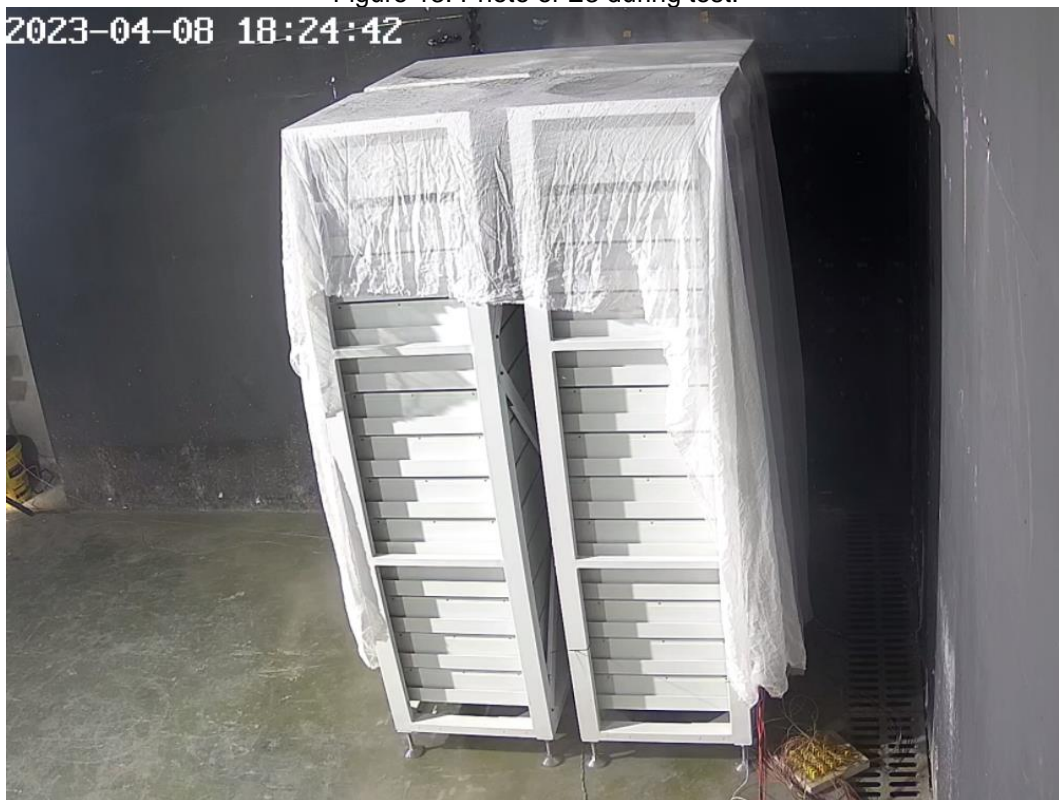
Figure 14. Photo of E4 during test.

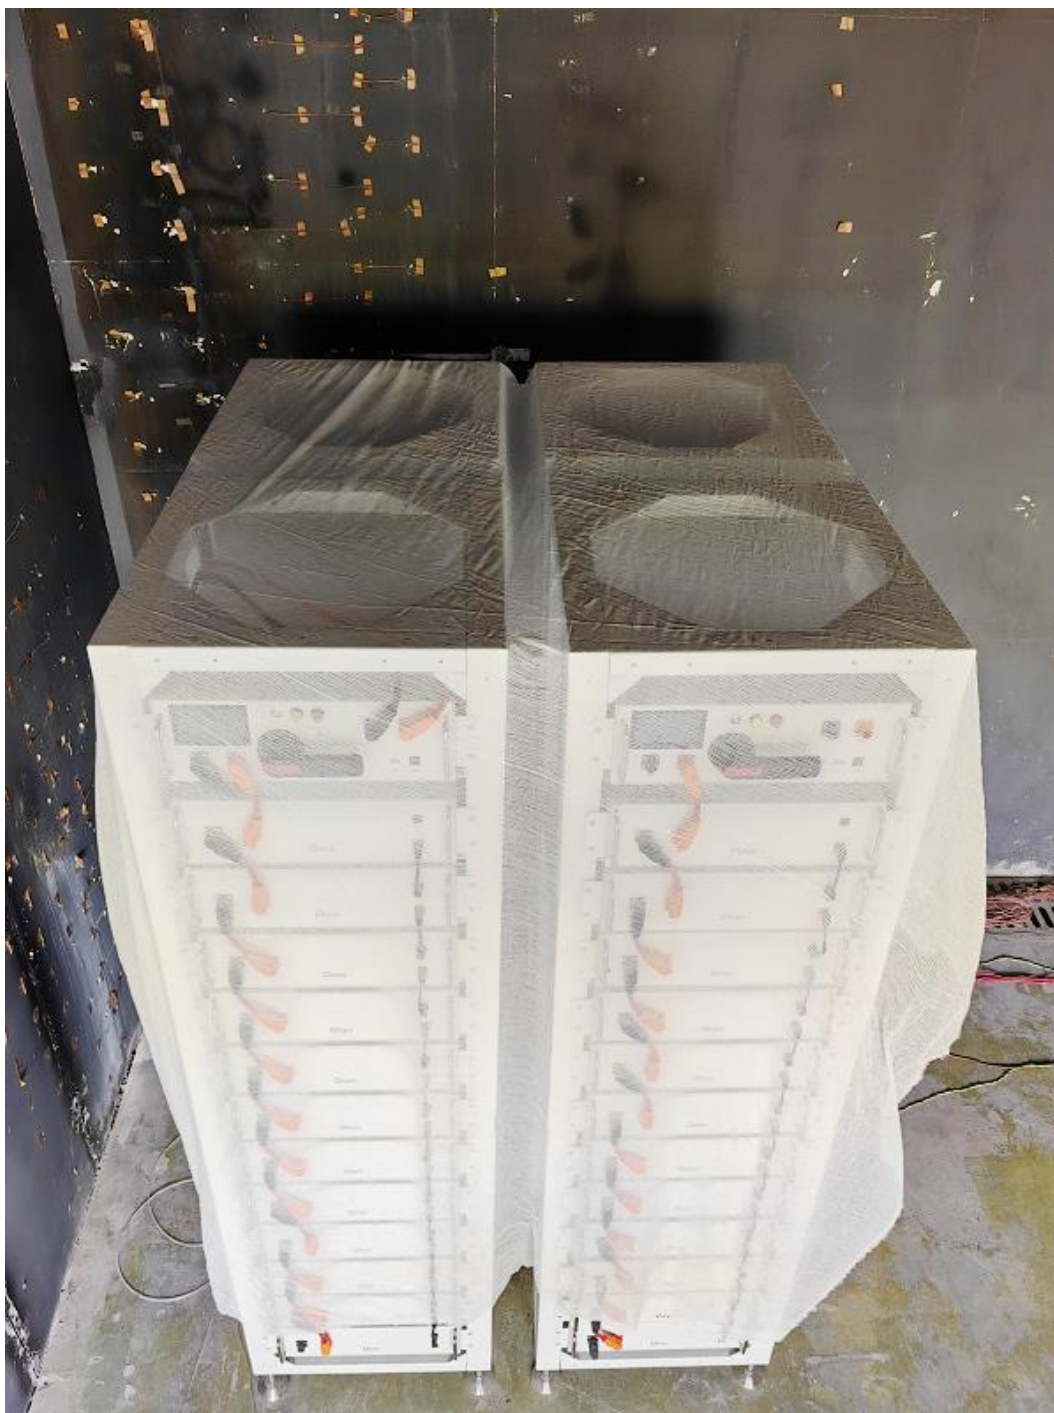
Figure 15. Photo 01 of initiating BESS unit and target BESS units after test.

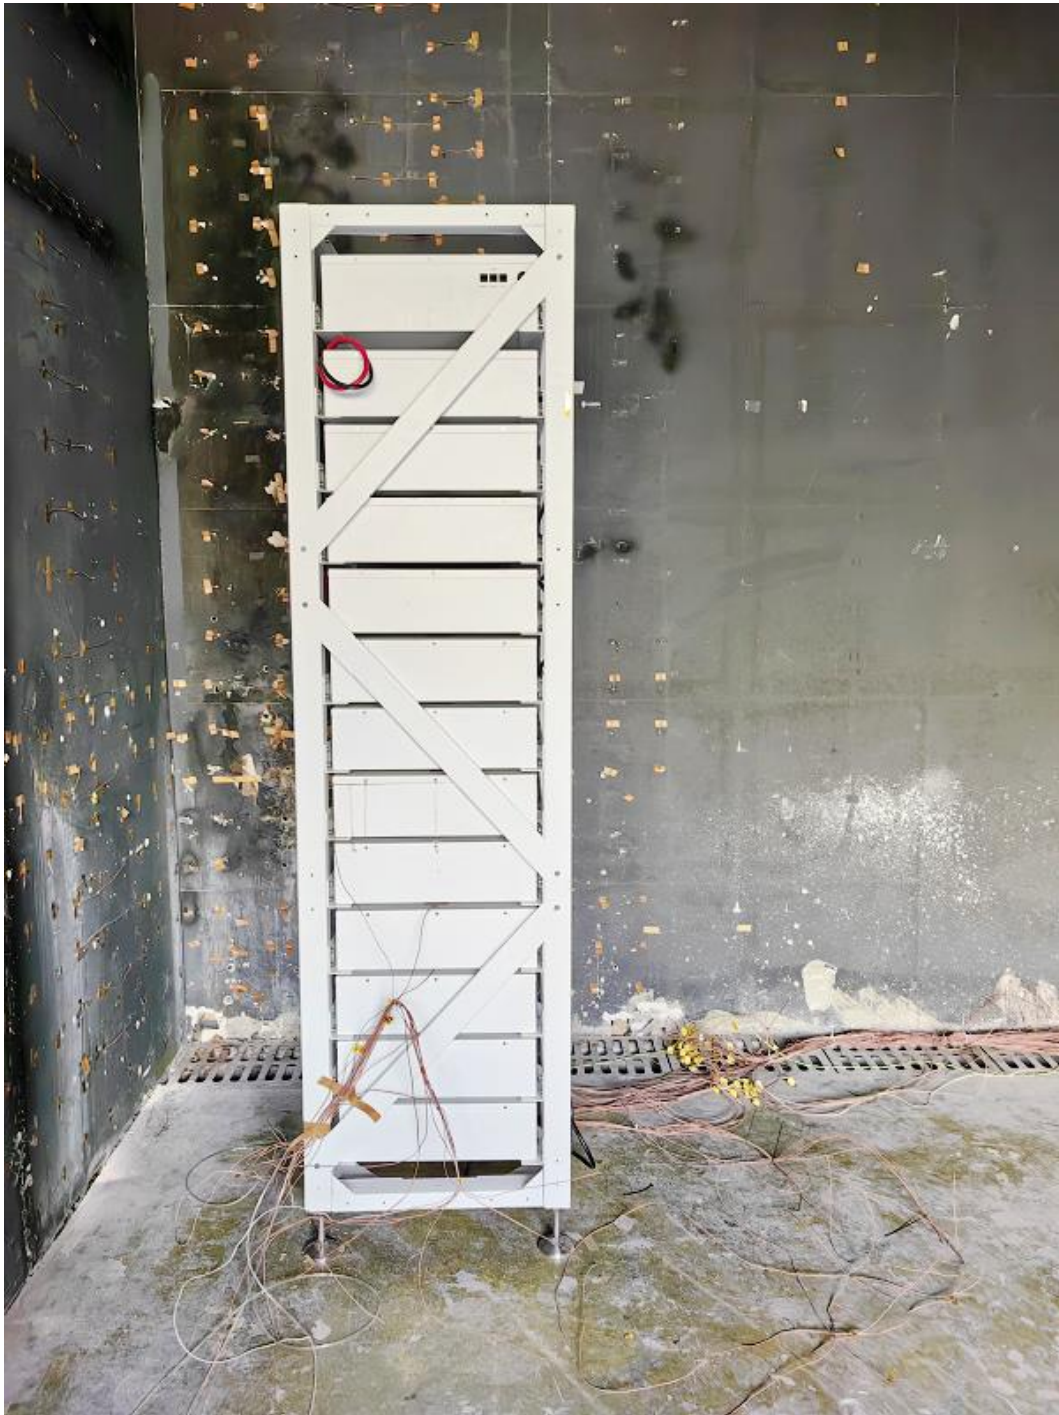
Figure 17. Photo 01 of initiating BESS unit after test.

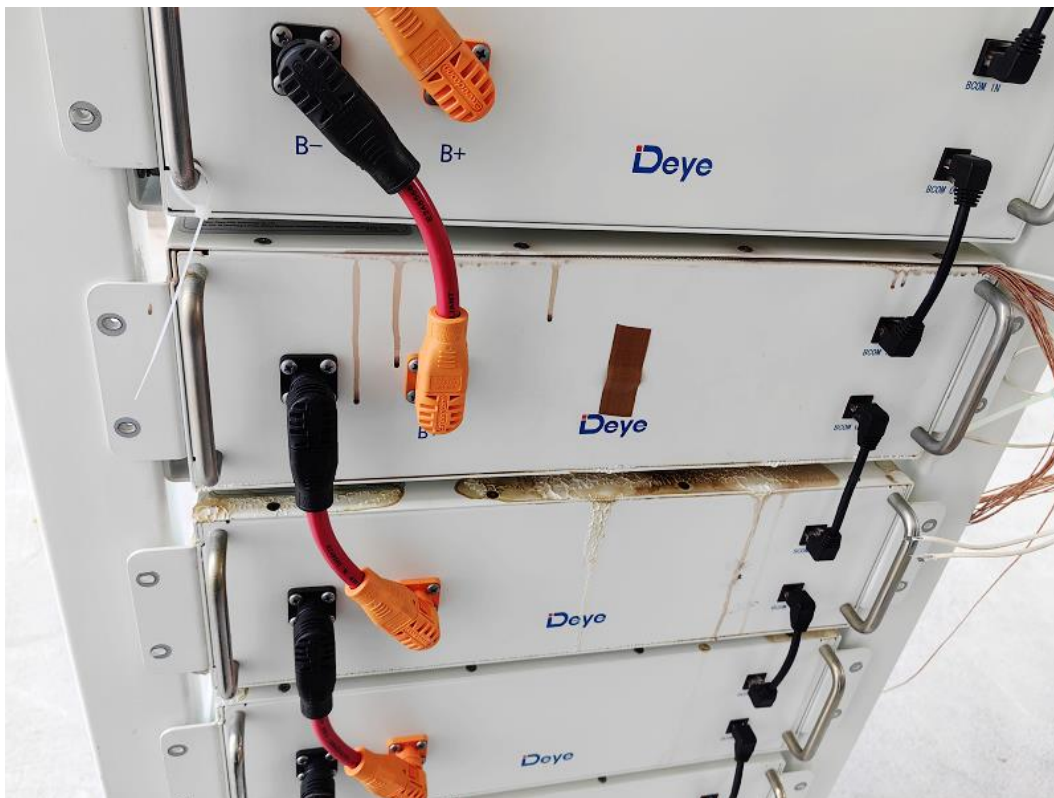
Figure 19. Photo 03 of initiating BESS unit after test

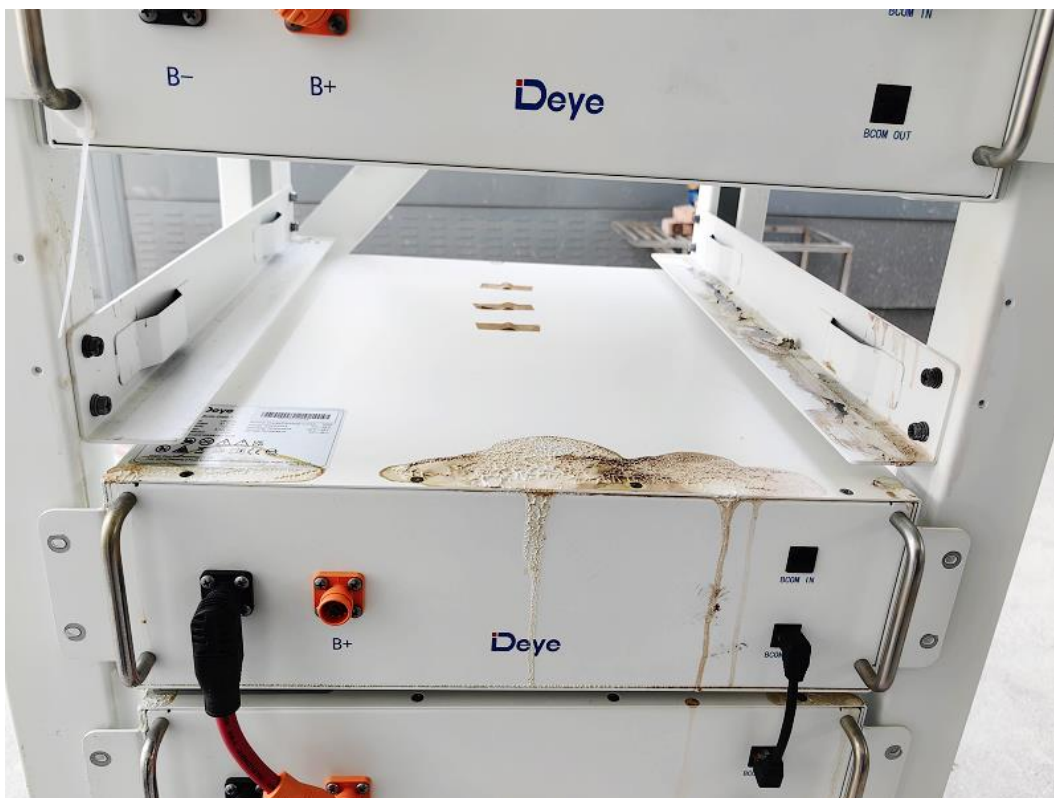
Figure 20. Photo 04 of initiating BESS unit after test.

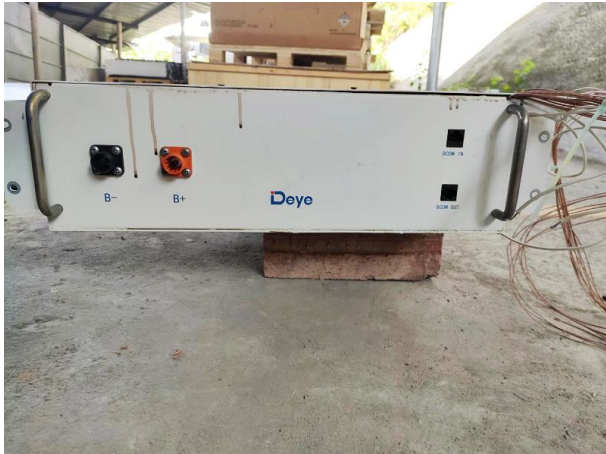
Figure 21a. Photo 01 of initiating battery module after test.

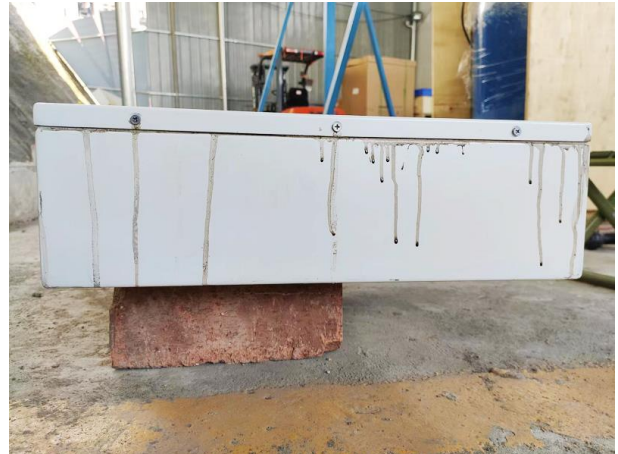
Figure 21b. Photo 02 of initiating battery module after test.

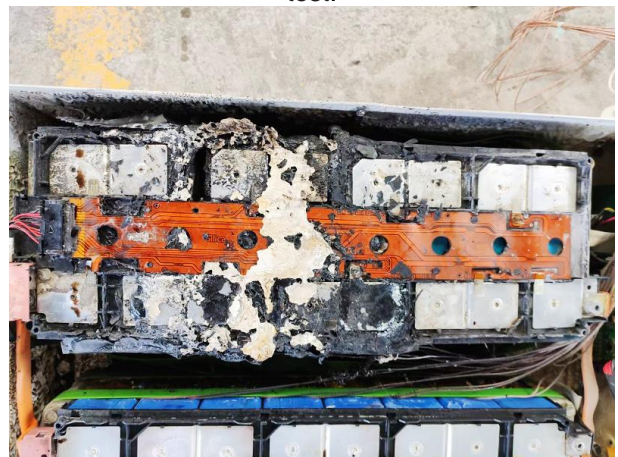
Figure 21d. Photo 02 of thermal runaway location.

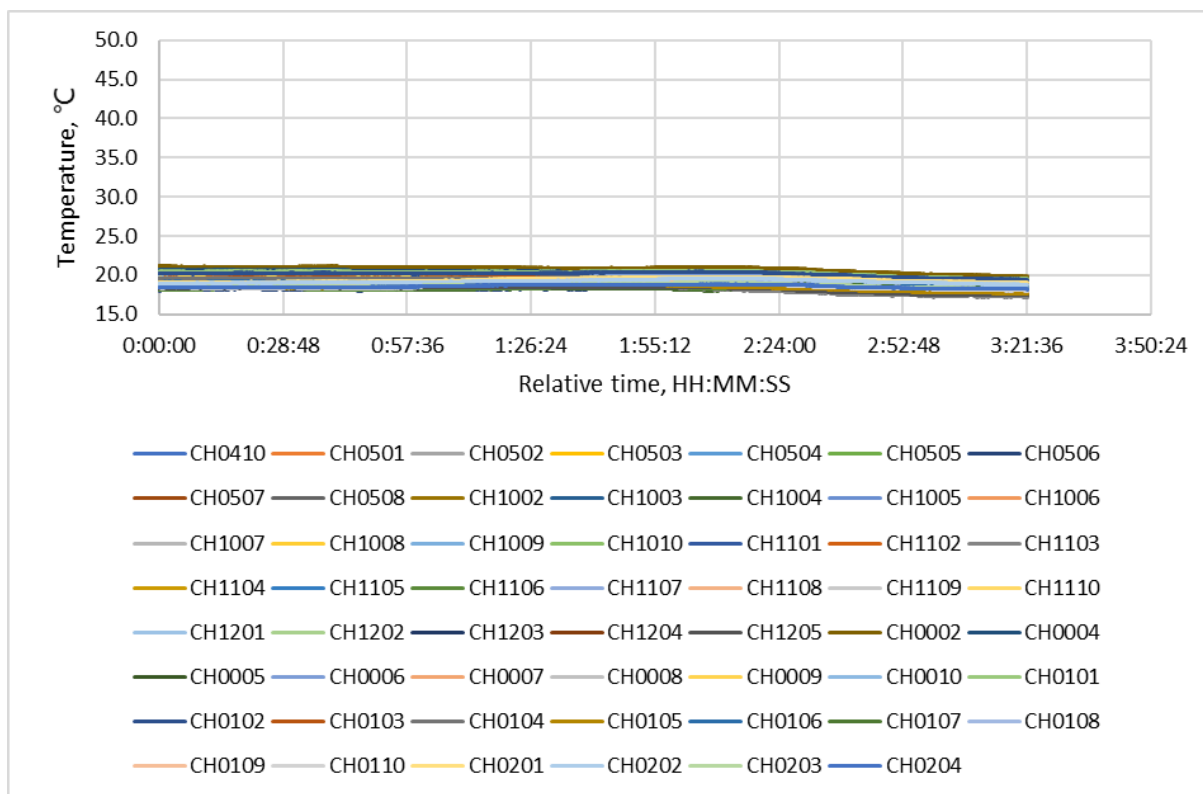
Figure 22. Temperature measurement results on wall A.

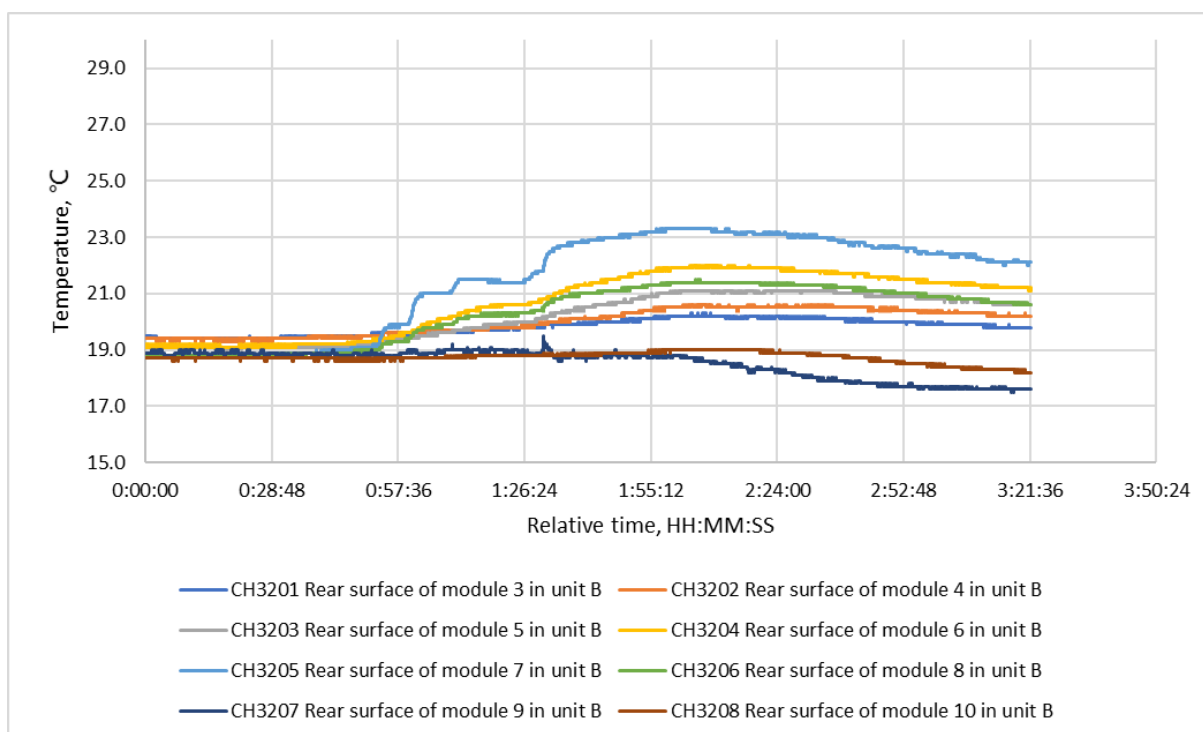
Figure 25. Temperature measurement results on target units (Unit B)

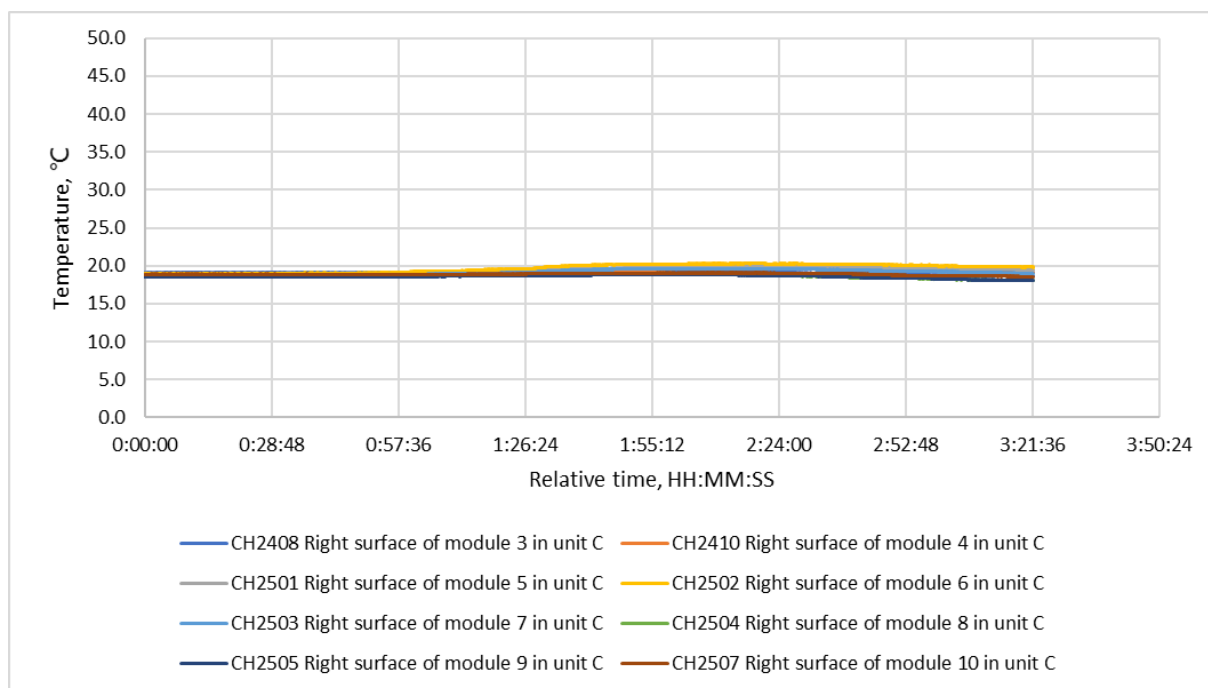
Figure 26. Temperature measurement results on target units (Unit C)

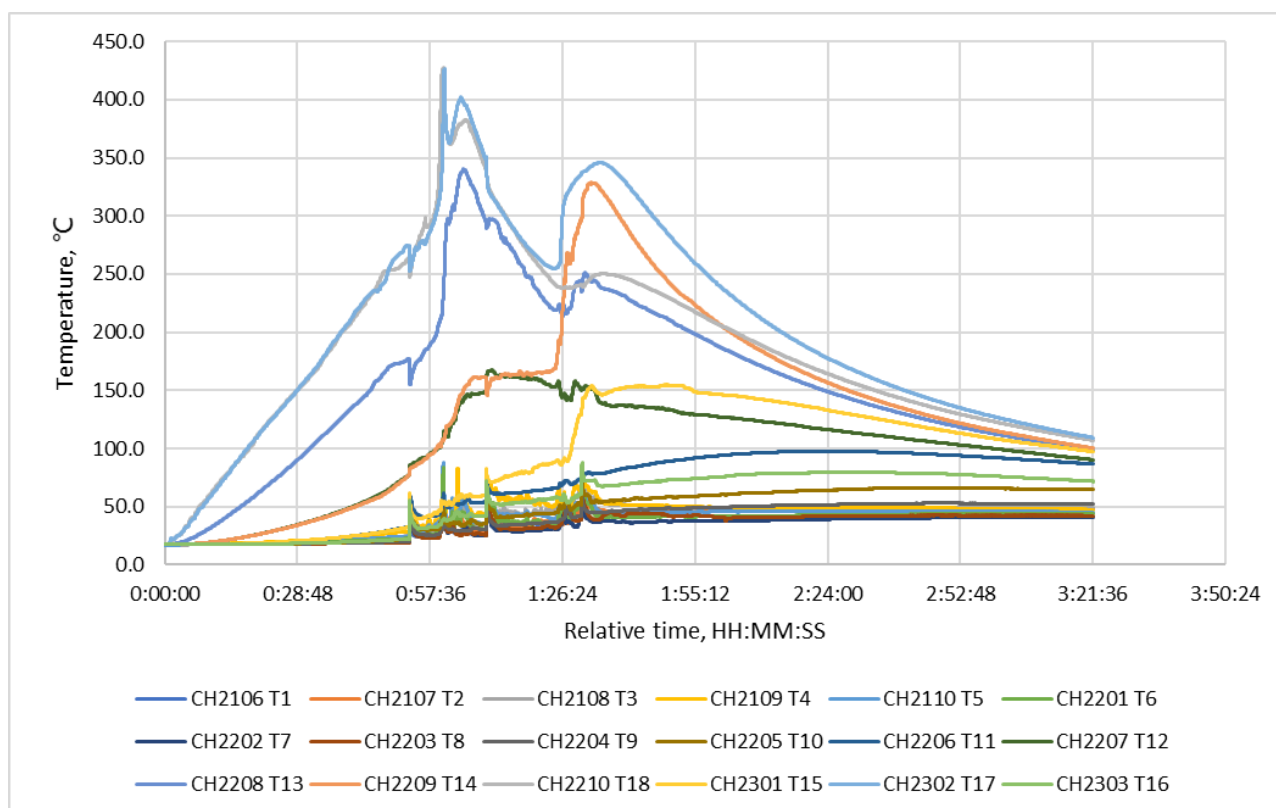
Figure 27. Temperature measurement results on the initiating module.
